(c) NATIONAL PHOTOGRAPHIC INTERPRETATION CENTER

ATTACHMENT TO M-6062 20 MARCH 1969 PAGE 1

HOA LAC AIRFIELD NORTH VIETNAM 2101N 10530E

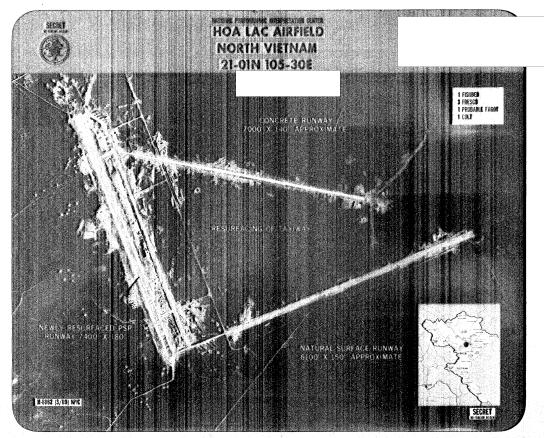
THIS BRIEFING BOARD DEPICTS THE RECENTLY COMPLETED RESURFACING OF THE MAIN RUNWAY, WITH PROBABLE RESURFACING OF THE PARALLEL TAXIWAY IN PROGRESS.

THE MAIN (NW/SE) RUNWAY HAS BEEN RESURFACED WITH PROBABLE PSP. A CENTER SECTION OF THE PARALLEL TAXIWAY IS APPARENTLY BEING RESURFACED WITH PROBABLE PSP.

Sanitized Copy Approved for Release 2011/09/12: CIA-RDP85T00339R000100180002-4 **SECRET** NO FOREIGN DISSEM (c) NATIONAL PHOTOGRAPHIC INTERPRETATION CENTER REFERENCE: ATTACHMENT TO M-6062 20 MARCH 1969 PAGE 2 POSSIBLE PSP SECTIONS ARE OBSERVED ALONG THE EDGE OF THE TAXIWAY. NEW RUNWAY MARKINGS ARE OBSERVED ON THE MAIN RUNWAY AND ON THE SECONDARY (EW) CONCRETE RUNWAY. THE NATURAL SURFACE (CONVERTED TAXIWAY) RUNWAY REMAINS UNCHANGED. AOB: 1 FISHBED 3 FRESCO 1 PROBABLE FAGOT 1 COLT REMARKS: HOA LAC IS NOW THE ONLY AIRFIELD IN NORTH VIETNAM WITH THREE SERVICEABLE RUNWAYS TWO OF WHICH ARE ALL WEATHER (ONE CONCRETE AND ONE PSP). HOA LAC IS THE
